3D Marine Seismic Survey

ACCOBAMS MMO & PAM Report
Marine Seismic Survey
EPI Report No. E1118

FINAL REPORT

TYPE OF MISSION: 3D MARINE SEISMIC SURVEY

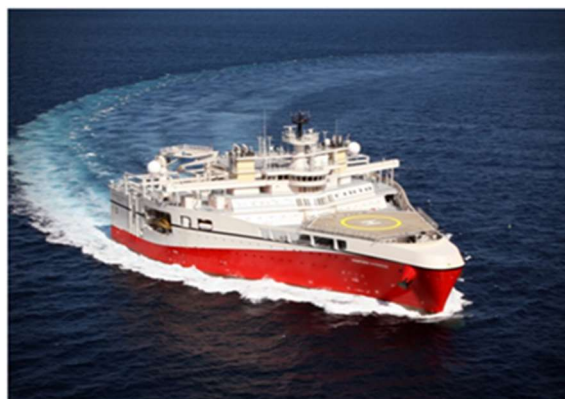
Figure 2 Ramform Hyperion

RAMFORM HYPERION SPECIFICATIONS

CALL SIGN	C6DB4
TYPE	SEISMIC Vessel
LENGTH	104.2m
BREADTH	70m
DRAFT	6.9 m (max)
GRT	20 637 t

The seismic survey was undertaken from seismic vessel *Ramform Hyperion* (Figure 2), which was assisted by three support and chase vessels, the *Thor Omega* (main support), the *Vernicos Sifnos* and the *EDT Zenon* (Figure 3 and 4).

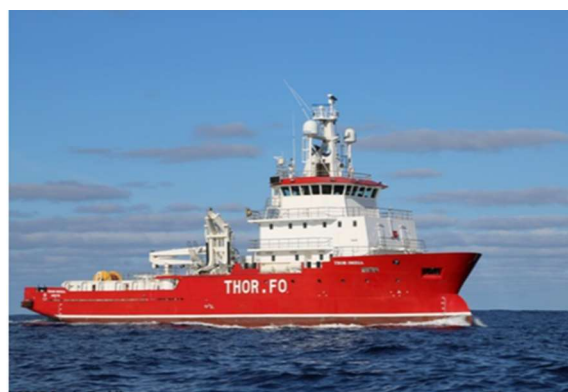
Figure 3 Thor Omega

THOR OMEGA SPECIFICATIONS

CALL SIGN	OZ2065
TYPE	SUPPORT VESSEL
LENGTH	55.10m
BREADTH	12.5m
DRAFT	4.85m
GRT	1153t

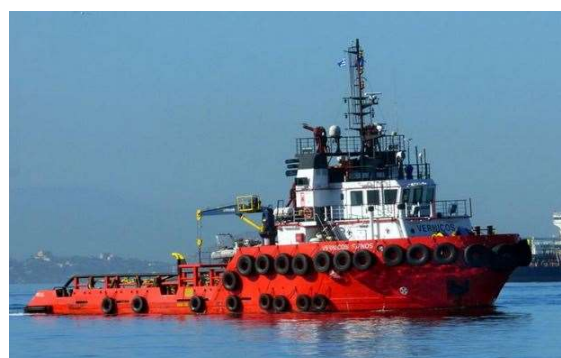
Figure 4 Vernicos Sifnos

VERNICOS SIFNOS SPECIFICATIONS

CALL SIGN	SVA7860
TYPE	SUPPORT VESSEL
LENGTH	38m
BREADTH	11.8m
DRAFT	5m
GRT	499t

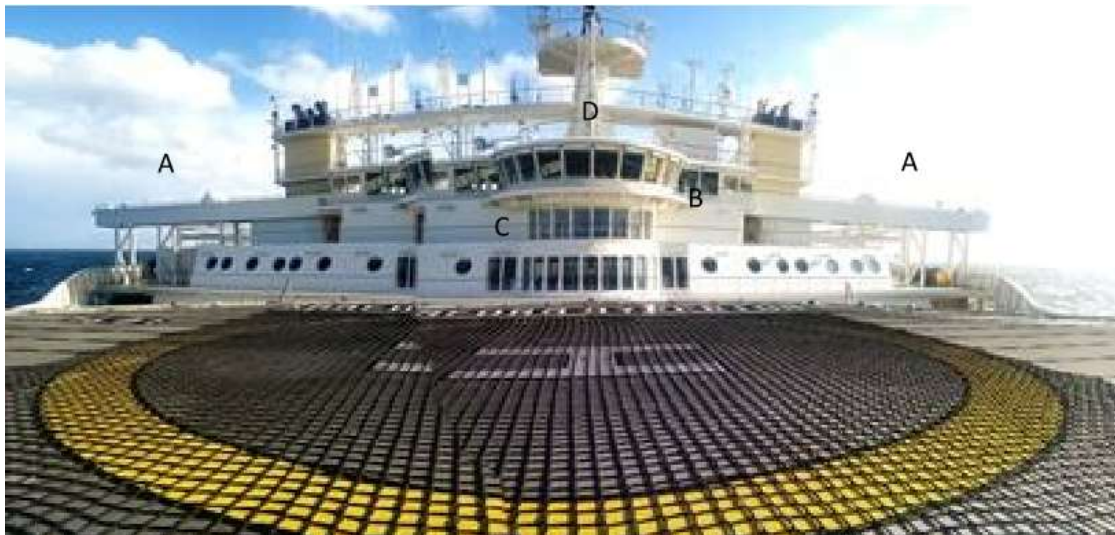
Figure 6 Observation Platforms.

The main platform of observation was located on the bridge, bridge-wings and monkey deck, which allowed 360-degrees of visibility at 20.27 m and 23.17 m elevation above sea level respectively. A front view lounge also available where the MMO station was located at 17.52 m high (Table 7 and Figures 7 and 8).

PLATFORM	HIGH (m)	VISIBILITY
Deck Wings (A)	20.27	360°
Bridge (B)	20.27	360°
Front View Lounge (C)	17.52	180°
Monkey Deck (D)	23.17	360°

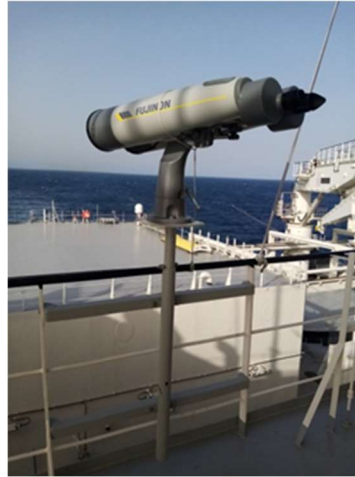
Figure 8 Long distances binoculars on 'Monkey Deck'

Table 7: Observation Platforms.

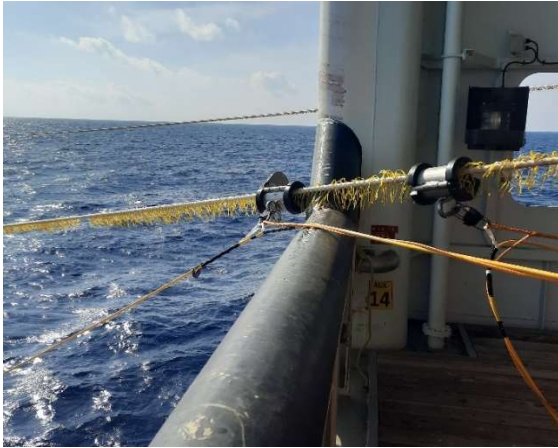
Figure 9. Slide collar over the lead-in (during deployment).

A sliding collar on a 12th lead-in on the port side was the towing point for the 90 m free end of the PAM cable that incorporates the hydrophone array (20 m). The cable between the collar and the stern of the vessel (120 m) was coupled with a rope to relieve the cable from towing forces (taped every 4-5 m on the cable) and both were suspended below the lead-in using a second sliding collar and four (4) large quick-links ('p-links'). The loop end of this rope on the stern end was used as the towing point of the PAM cable on the stern (using a large quick-link attached to rope running on an overhead winch on deck). Both sliding collars and four (4) quick-links were attached to the cable via double rope eyes and using cable grips, which distribute the tension over the sheath of the cable when it is being towed and when the cable and collar are winched back onboard. The last 40 m of PAM cable from the stern towing point to the deck connector were laid on deck in a figure 8 arrangement close to the deck connector.

Both sliding collars and all four (4) quick-links were submerged after deployment. A chain weight of 3 kg was attached with tape to the PAM cable at 15 m distance from hydrophone array. The depth of the hydrophone array was between 20 – 30 meters approximately during the survey, with variability depending on the vessel speed. The cable was loaded onto a mechanical winch, which was utilized to facilitate cable deployment and retrieval.

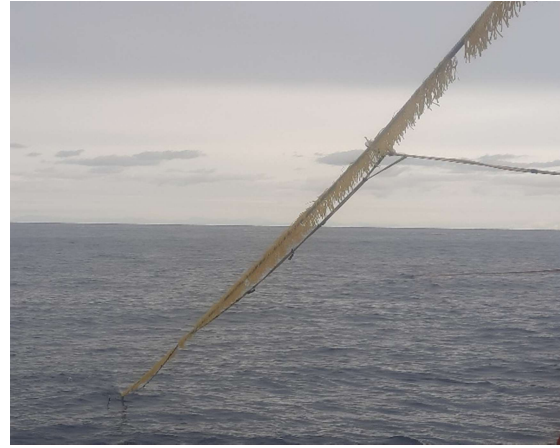
Figure 10. Cable deployed on lead-in 12.

The PAM tow cable was deployed and recovered to spur-line winches, once the seismic streamers and paravanes had been fully deployed. The end of the cable was connected to the deck cable that was installed between the streamer deck and the rack room when *Ramform Hyperion* was rigged.

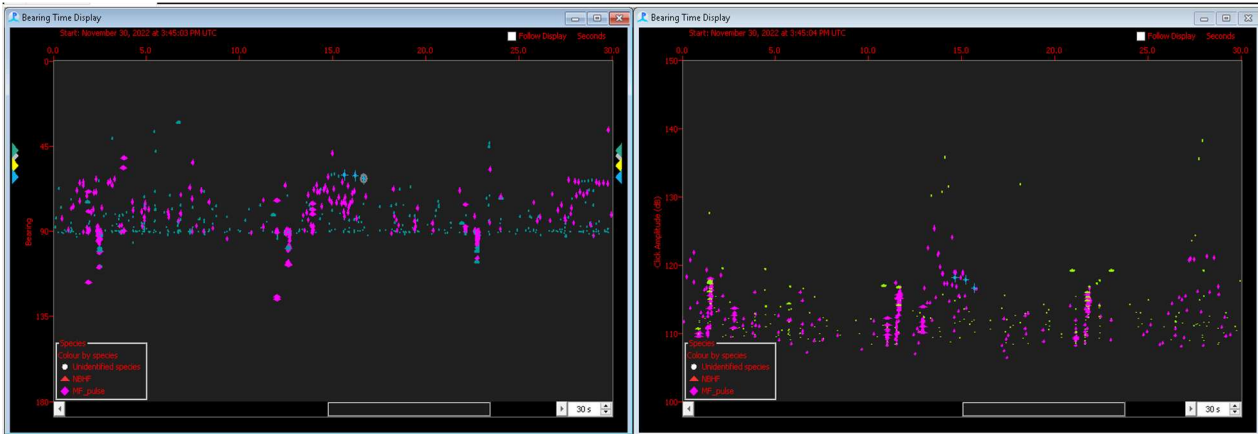
Acoustic detection ID# 500: On the 30 November 2022 at 15:38 UTC, there was one (1) detection of an unidentified dolphin at an initial bearing of 65°/295° from the vessel heading. Echolocation click trains were detected on the mid-frequency (MF) spectrogram and the high frequency (HF) click detector, displaying a frequency range of 18-65 kHz and low amplitude, below 120 dB re 1µPa. At 15:43 UTC, four (4) upswEEP whistles, each with 7 to 11 kHz frequency, were aurally detected and identified on the spectrogram during the post-analysis. Echolocation click trains started reaching higher amplitudes with a peak of 137 dB re 1µPa until the last signal was detected at 15:46 UTC. The clicks were not localized on the map. However, the signal was very faint so the Operator confirmed the detection was outside of the exclusion zone. Since the vessel was in stand-by and sources were non active, no mitigation action was required, as per protocol.

Figure 16: Acoustic Detection ID#500. Echolocation click trains.

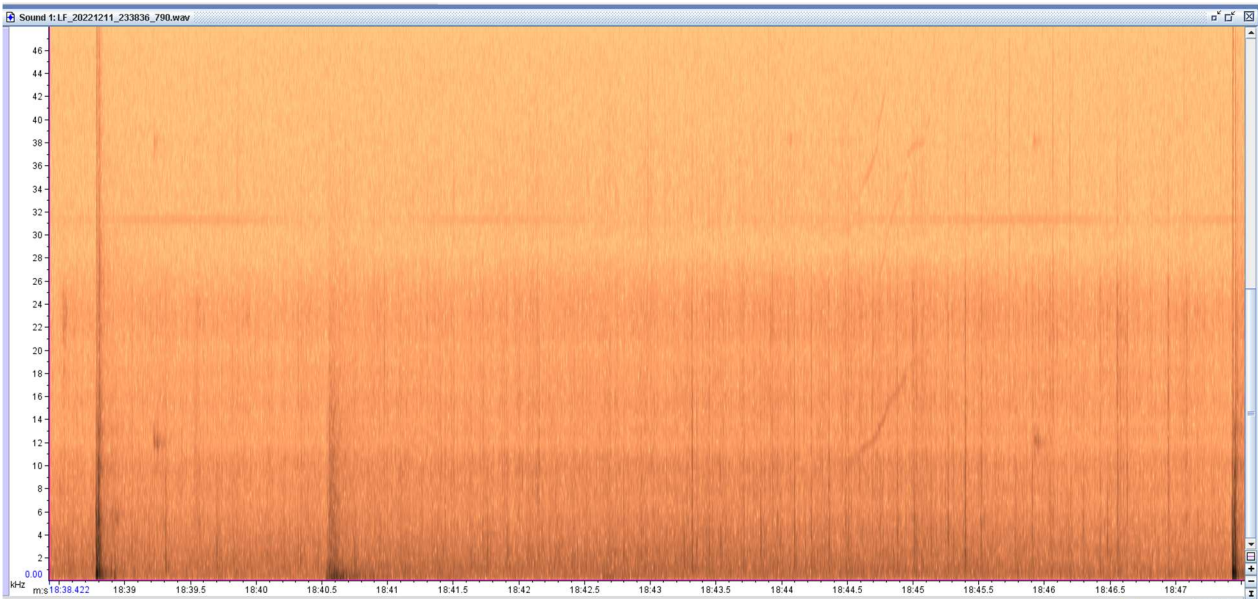
Acoustic detection ID# 501: An unidentified dolphin was registered on 11 December 2022 from 23:47 to 23:58 UTC when sources were active on full power. There were echolocation click trains detected on the spectrogram and the HF click detector with an initial bearing of 43°/317° from the vessel heading. The detection was not able to be localized on the map. Whistles of 9 to 19kHz frequency and amplitude 142 dB re 1 µPa were shown in the spectrogram and the radar display. Contours detected, 15 whistles in total, were mostly upsweep with inflections and harmonics present in some of them. The whistles started during full power at 23:51 UTC and ended at 23:58 UTC. Since the signals were very faint, the estimated distance to the source was determined to be outside of the EZ.

Figure 17: Acoustic Detection ID #501 Whistle with harmonics (post-analysis in Raven)
