2D Marine Seismic Survey

ACCOBAMS MMO and PAM Report
Marine Seismic Survey
EPI Report No. E0479

Client	Hellenic Petroleum Group
Area	Ionian Block
Survey	
Regulatory Reference	73695/4484
Dates	10 th February – 3 rd March 2022
Contractor	Shearwater Geoservices
Vessel	SW Cook

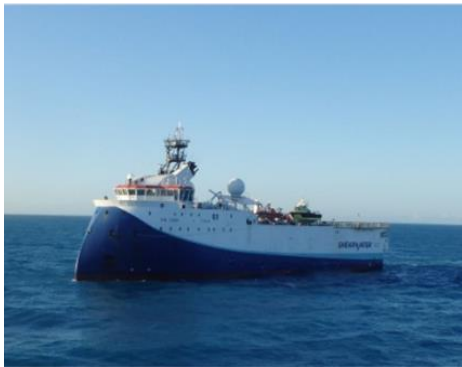
Figure 2 SW Cook (Credit: marinetrffic.com)

SW COOK SPECIFICATIONS	
CALL SIGN	5BPC2
TYPE	2D SEISMIC Vessel
LENGTH	88.80 m
BEAM	19 m
DRAFT	6.6 m (max)
GR	6599 tons

The seismic survey was undertaken from seismic vessel SW Cook (Figure 2), which was assisted by one chase/support vessel, the Platytera (Figure 3).

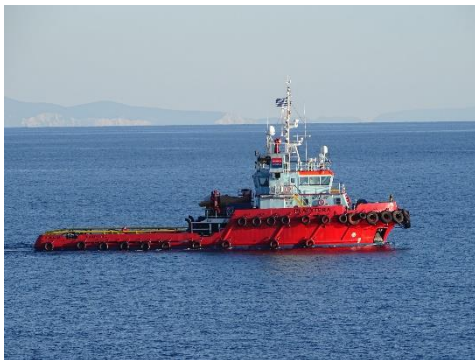
Figure 3 Playtera (Credit: MFO/PAM Team)

PLATYTERA SPECIFICATIONS	
CALL SIGN	SVA7933
TYPE	TUG Vessel
LENGTH	40 m
BEAM	11.8 m
DRAFT	3.80 m (max)
GR	499 tons

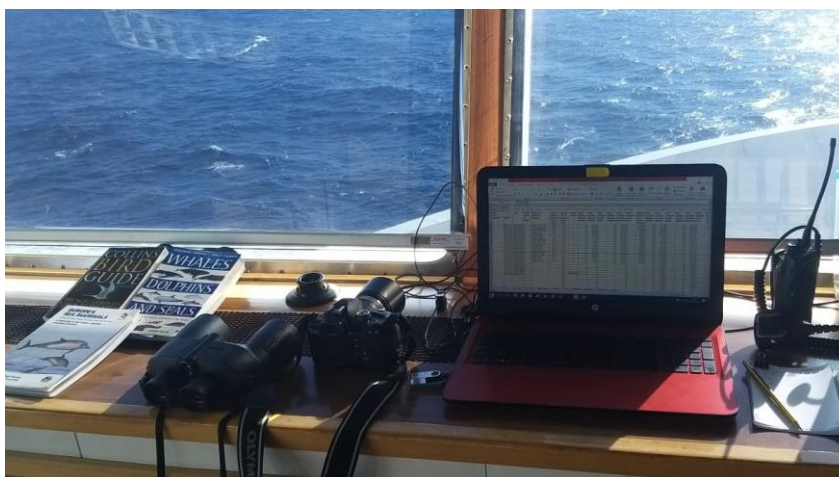
Figure 5 MFO monitoring station on the bridge of the SW Cook (Credit: MFO/PAM Team)

The main platform of observation was on the bridge, which allowed 360 degrees of visibility at 14.5 m elevation above sea level, and where the MFO station was located (Figure 5).

When and if required for tracking sighted animals, both D-deck (13.2 m) and Heli-deck (10.5 m) could be used, enabling a better view of the bow and the gun-arrays, respectively.

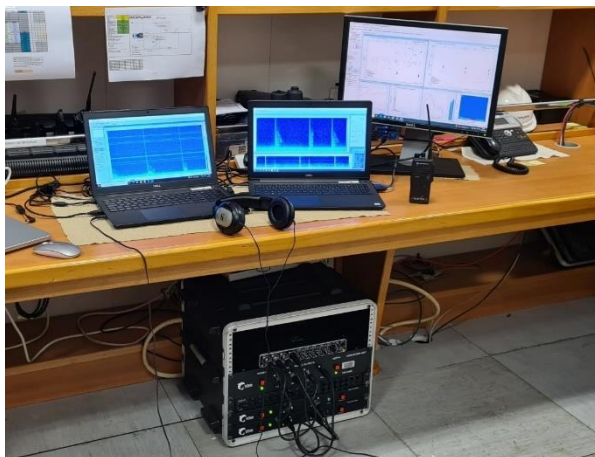
Figure 6 PAM monitoring station in the instrument room of the SW Cook (Credit: MFO/PAM Team)

During the survey, experienced PAM Operators maintained an acoustic monitoring 24 hours, in accordance with recommendations in the ACCOBAMS Guidelines and the requirements stipulated within the EAP. The PAM station was located within the instrument room, allowing ease of communication with the seismic observers (Figure 6).

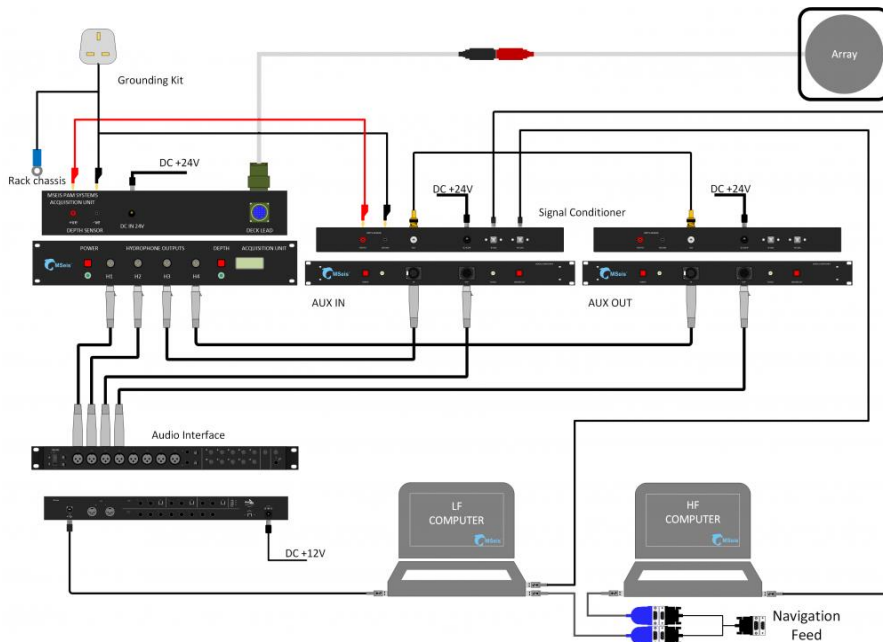
Figure 11 MSeis Night Hawk III Block Diagram Dual Setup with 4 channel LF and 2 channel HF using dual signal conditioners (Source: MSeis)

A dual setup was configured for a two-channel HF input (H3 and H4) to the HF laptop (Figure 11). Two Signal Conditioner channels were used to split signals from two hydrophones into high frequency NIDAQs.

This configuration allowed the deduction of bearings to marine mammal vocalizations obtained through the whistle/moan and click detectors. Bearing overlays in the map display could then be used to estimate the distance to the animals. In addition, distances could also be evaluated from relative amplitude and frequency content (as a proxy for distance), along with waveform characteristics and spectral energy for species identification.

A high-frequency spectrogram was configured with a 0-125 kHz frequency range. Also, a click detector was incorporated to detect clicks. The trigger threshold was set to 8 dB for this click detector. The HF laptop was also used for headphone monitoring.

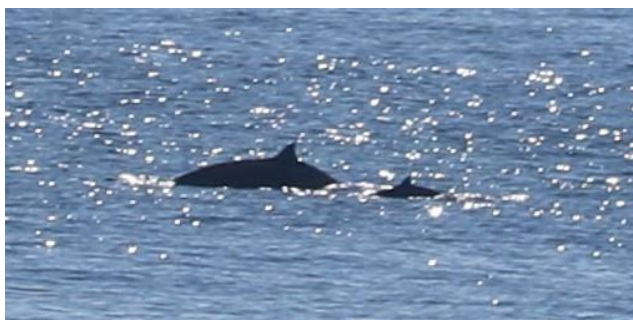
Figure 17: Cuvier's Beaked whales surfacing (Photo credit: Patrick Lyne)

On 11 February 2022 at 10:20 UTC, at a bearing 30° off the bow and 170° from north, activity was seen at 1000 m. Cuvier’s beaked whales with a brown colouration and dorsal fin set two thirds of the way back along a six (6) to seven (7) m body (Figure 17). At least two Cuvier’s beaked whales were seen with unidentified dolphins. One animal appeared smaller and was a possible juvenile or calf. Initially, animals appeared to be travelling to the east but possibly changed direction. No shutdown was required as this was still within the required delay period from the previous shutdown and with ample time to start of pre-watch (over 120 minutes) before the next line. It is probable, as the vessel was travelling towards the initial sighting, that these represent the same animals and suggests little movement between the sighting at 09:41 UTC and the potential subsequent sighting at 10:20 UTC. The vessel covered approximately four (4) km between these two sightings. The animals were not detected acoustically.

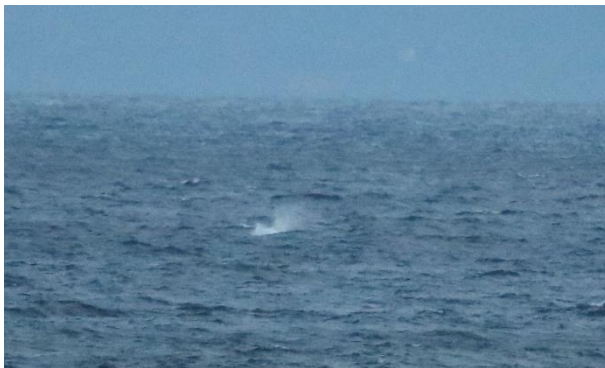
Figure 18: Sperm whale blow (Photo credit: MFO/PAM Team)

On 1 March 2022 at 05:40 UTC, a low blow was first spotted (Figure 18) which was positively confirmed to be a sperm whale at 05:44 UTC. The source was operating at full power and a shutdown of operations was carried out at 05:44 UTC. The animal was at a bearing 90° from north and 95° from the bow on the starboard side, at an approximate distance of 900 m from the vessel and 923.5 m from the center of the source (within the Exclusion Zone). The sperm whale moved away rapidly and after a short dive, the animal reappeared at the same bearing at 1000 m. The whale was blowing for a while and was last sighted when fluking into a dive at 06:12 UTC. The animal was not detected acoustically.

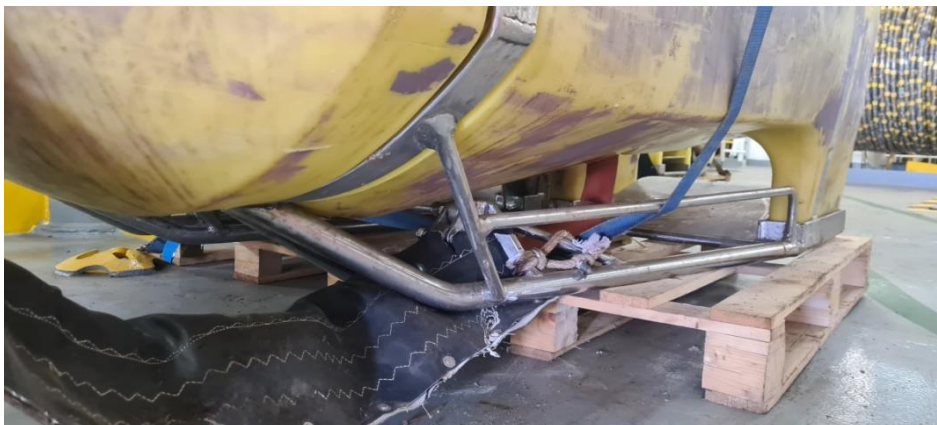
Figure 21 Turtle guard SW Cook (Credit: MFO/PAM Team)

- Turtle guards (Figure 21), a structure welded to the underside of tail buoy designs, aims to exclude sea turtles from becoming fatally entrapped in gaps at the front of the tail buoy undercarriage. In the event of turtle entrapment in seismic equipment, the Contractor's appropriately trained staff must intervene immediately to remove the trapped animal, weather permitting.
